# **RABY PARK WETHERBY**

## **MANAGEMENT PLAN**

**An Arboricultural Report on the Safety and Management  
Requirements of the Trees**

**28 January 2006**

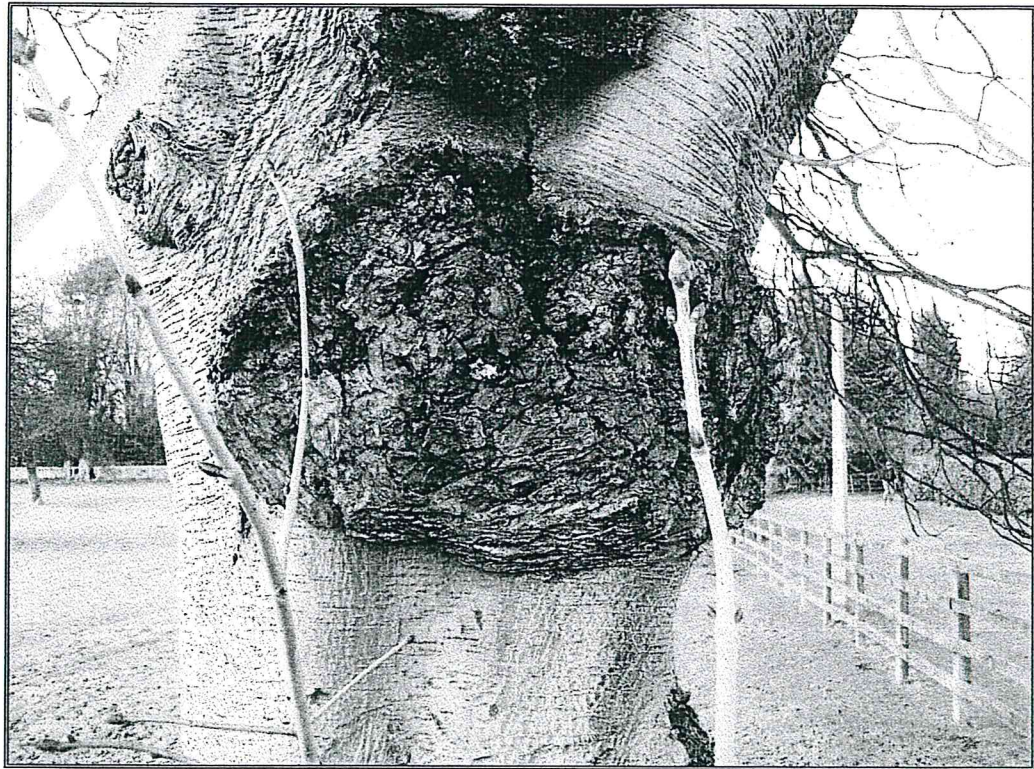
**Figure 3**

Many of the red horse chestnuts have cankered trunks and branches (see Figure 1). These cankers are caused by 'bud proliferation'. I have included an extract about bud proliferation of red horse chestnuts from Strouts and Winter (1994) as Appendix 6. These cankers will decay and in time compromise the structural stability of the affected trees but at present I do not believe that any pose a significant risk because of it.

A photograph showing a canker on the trunk of a red horse chestnut.

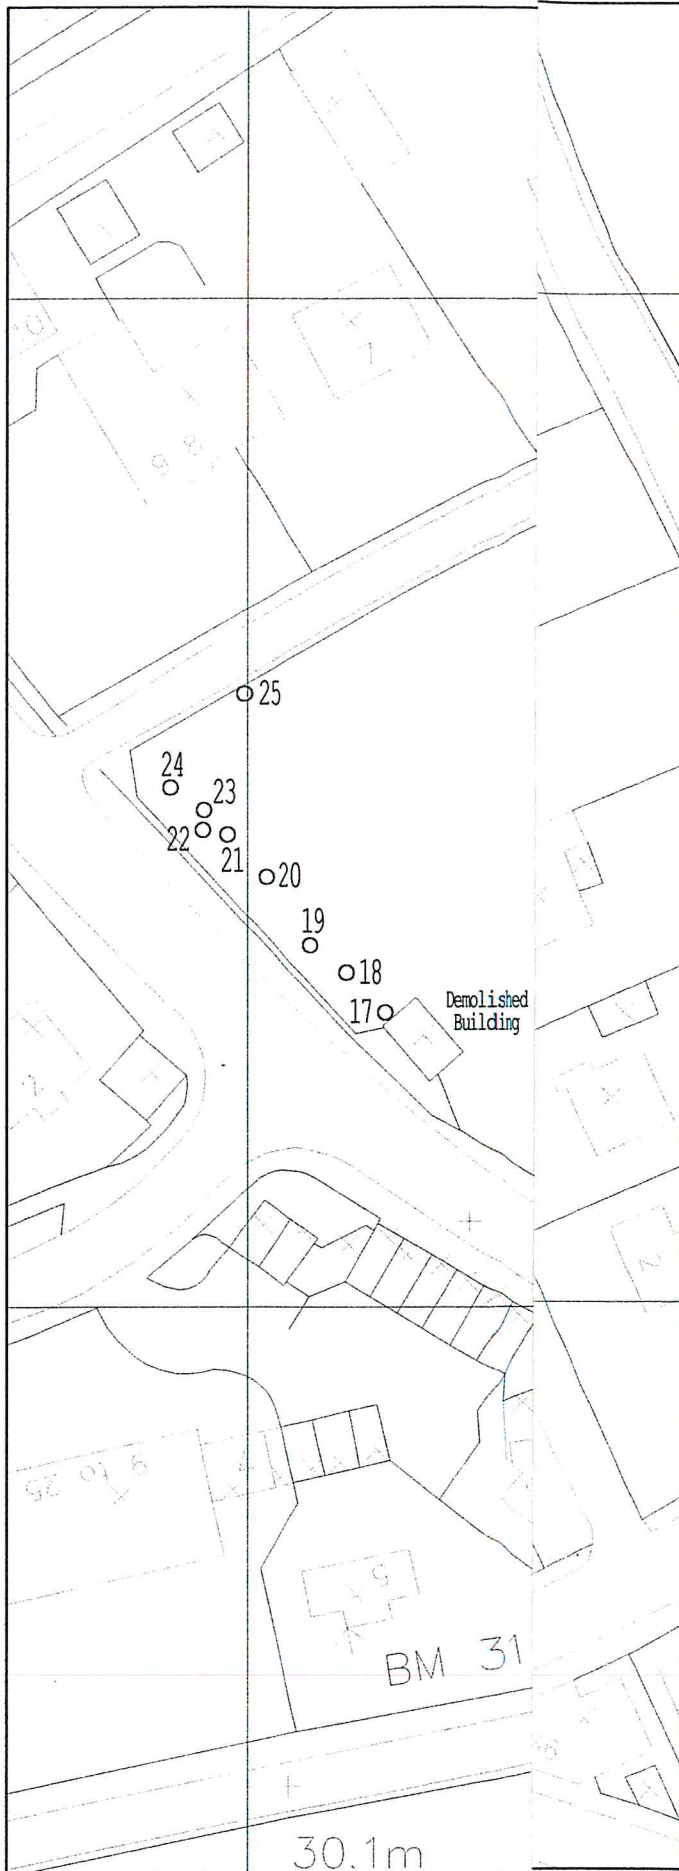
I inspected the trees in Raby Park on 21 January 2006. I have shown the approximate locations of the forty seven trees that I inspected on Figure 4 and describe their condition in Appendix 3. A number of trees have bark damage on their root buttresses. I believe that this may have been caused by grass cutting machinery driving too close to the trees.

<b>Tree Number</b>	<b>Species</b>	<b>Remedial Action</b>	<b>Details</b>	<b>Priority</b>	<b>Category</b>
25	Red Horse Chestnut	See details	Reduce the lowest branch overhanging the drive by 2m to suitable growing points.	Medium	1
27	Ash	Fell	Fell if this tree is thought to be out of place.		2
		Reduce	Reduce one of the leaders to allow the other to become the dominant one and form a better tree.		2
31	Red Horse Chestnut	Make safe any unstable, dead or defective branches	Particularly remove the hanging branch.	Medium	1
34	Red Horse Chestnut	Make safe any unstable, dead or defective branches		Medium	1

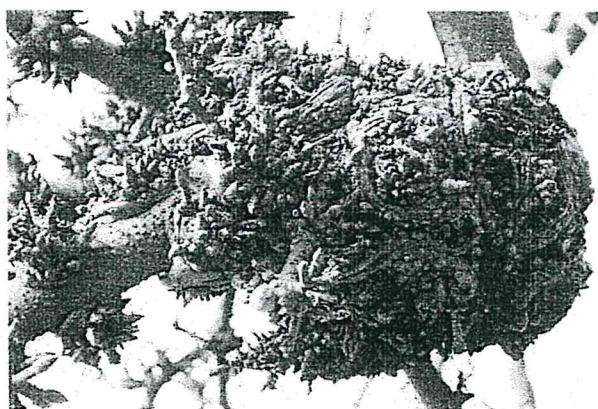
Fig. 61

**Symptoms & Diagnosis:** In winter, conspicuous clusters of buds are evident on branches or stems (Fig.61), or in summer crowded clusters of weak shoots bearing dwarfed leaves are noticeable. The clusters may consist of just a few buds or shoots on a smooth, blister-like bark swelling a few centimetres across or of a very large number packed close together over a swelling half a metre or more across and 15 cms thick. The whole structure may be alive or some buds, twigs and bark may be dead, or the whole may be dead and it and the underlying wood decaying. Some swellings are much greater in diameter than the branches bearing them and may lack buds and shoots.

**Significance:** For many years merely disfiguring, but if the galls die and the underlying wood is invaded by wood-rotting fungi the tree may become unsafe.
