# **RABY PARK WETHERBY**

## **MANAGEMENT PLAN**

**An Arboricultural Report on the Safety and Management  
Requirements of the Trees**

**28 January 2006**

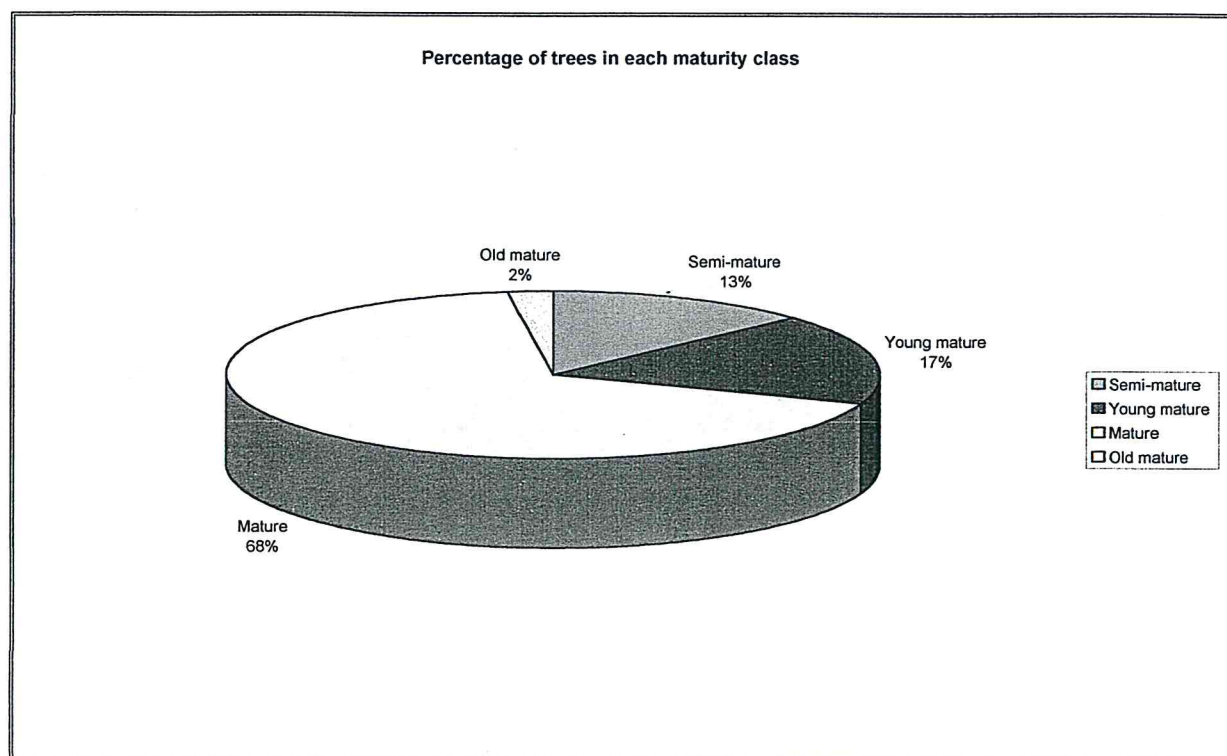
**Figure 1**

Figure 1 shows the percentage of trees in each maturity class. Sixty eight percent of the trees (31 trees) are mature. There is one tree that I have classed as 'old mature,' this is an Norway maple that is probably no older than the other Norway maples growing in the area but it is suppressed and as a consequence has growth characteristics of a much older tree.

A pie chart showing the percentage of trees in each maturity class.

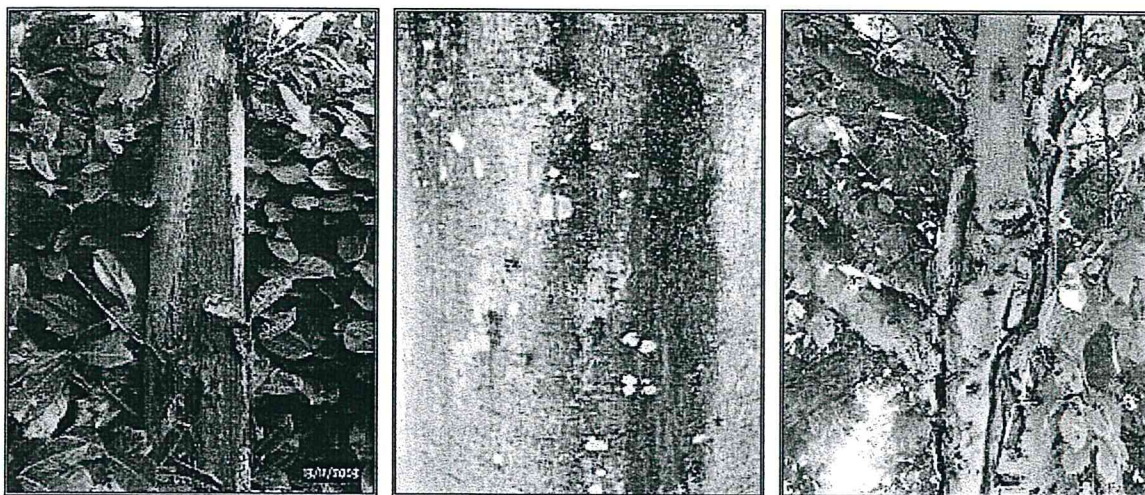
**Bleeding Canker of Horse Chestnut**

Stem bleeding on horse chestnut in the UK was first reported in the 1970s, when the cause was found to be a fungal pathogen known as *Phytophthora* (Brasier and Strouts, 1976). The same disorder had also been recognised in the USA much earlier in the 1930's (Caroselli, 1953).
