**CONDITION AND  
MAINTENANCE REPORT**

**WETHERBY TOWN HALL,  
WETHERBY, WEST YORKSHIRE**

**MAY 2020**

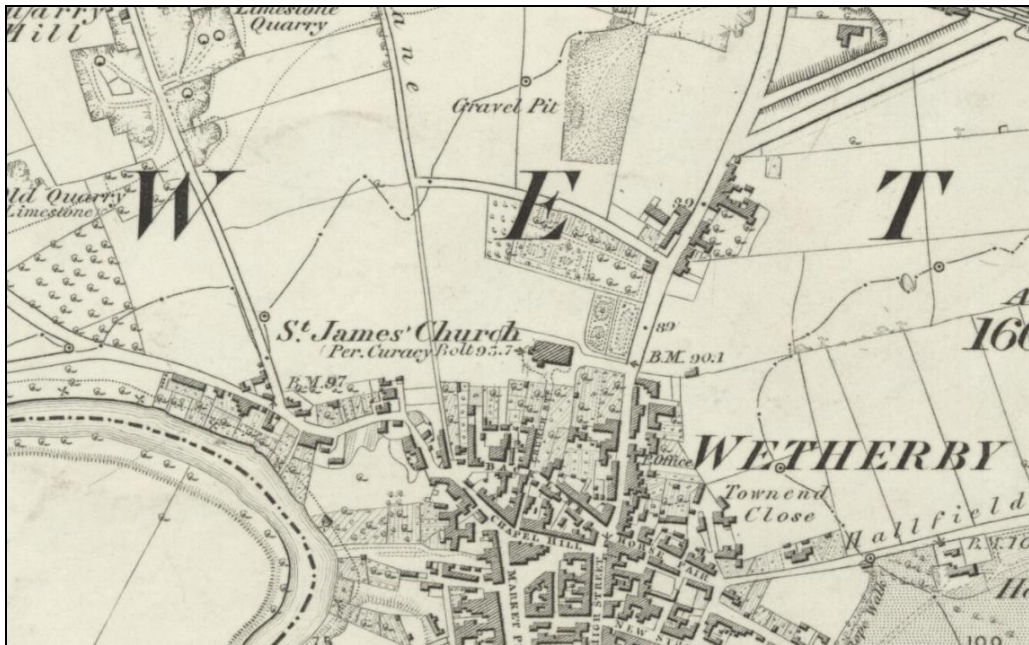
*Figure 1: OS Plan from 1850. The newly built Town Hall can be seen in the centre of Market Place.*
